Blackout in Spanish Peninsular Electrical System the 28th of April 2025

11/06/2025

System Operation Division
June 2025

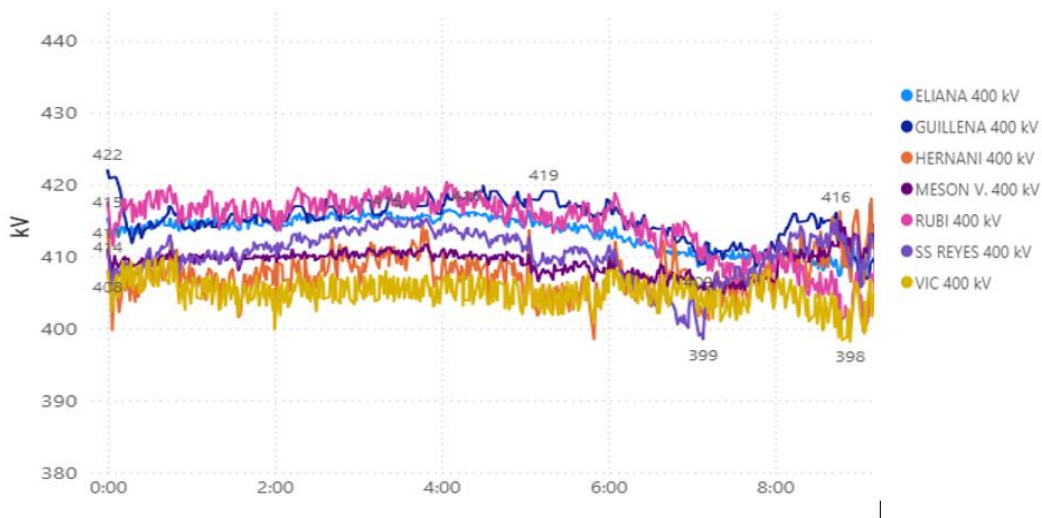
The voltage profile in the Transmission Network remained stable with minimal voltage variations until 6:00 h, coinciding with a change in the interconnection exchange with France. From that moment, voltages dropped at the same time as the demand rose until 9:00 h. During this period, two very low amplitude interarea oscillations appeared in the European system without any consequence, which is within the normal range for an electrical system with the size of the European one.

Figure 1. Voltage in 400 kV transmission network from 00:00 to 09:00 h

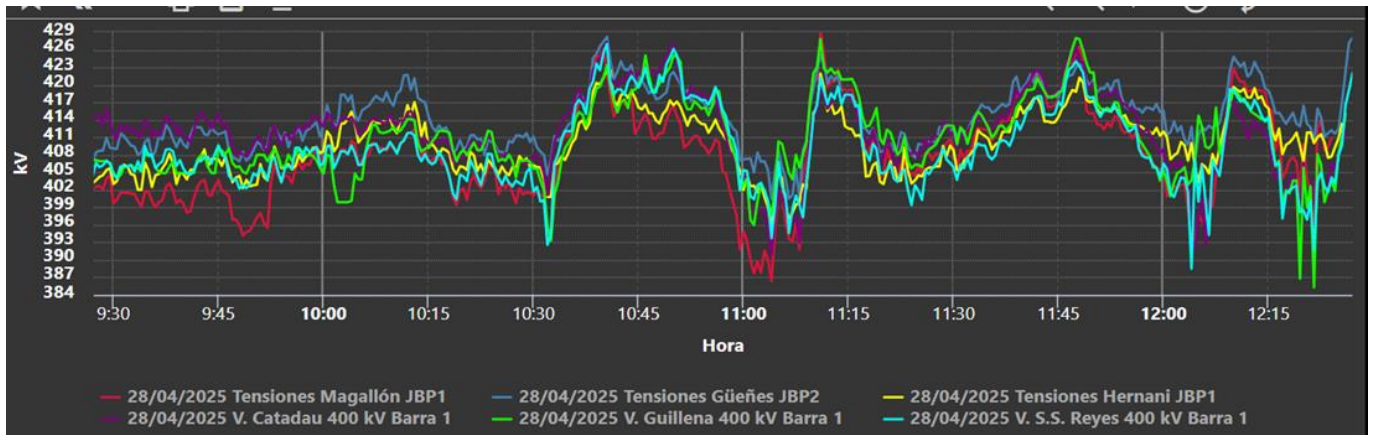
occurred in the transmission network substations, particularly around 11:00 h, when voltages dropped below 400 kV by about 10 kV.

Figure 2. Voltage in 400 kV transmission network from 09:30 to 12:30 h

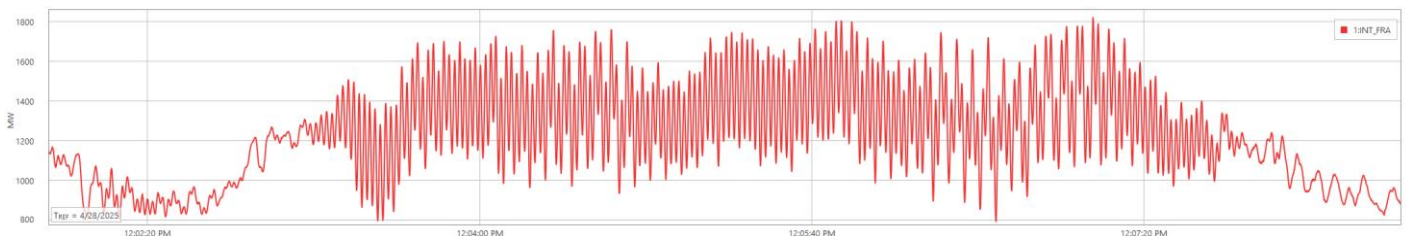
At **12:03 h, and for a duration of 4 minutes and 42 seconds, a significant 0.6 Hz oscillation** was observed in the electrical system. Coinciding with this, the damping of the 0.2 Hz frequency range dropped from 20% to 5%. Prior to the event, system voltages were close to nominal values, but the **oscillation caused a decrease in average voltage, with fluctuations reaching up to 30 kV** in the most extreme cases, ranging between 375 kV and 410 kV depending on the substation. The oscillation could be seen also in the power exchange with France.

Figure 3. Exchange Spain-France between 12:02 to 12:08 (0.6 Hz oscillation)

In response to this situation, REE Control Center **activated the pre-established measures** to improve oscillation damping and attempt to eliminate it:

- Coupling 400 kV transmission lines to reduce the system impedance.
- Reduction of export exchange with France by 800 MW until setting an export program of 1,500 MW.
- Changing the HVDC link operational mode with France to constant power mode (setpoint: 1,000 MW from Spain to France).

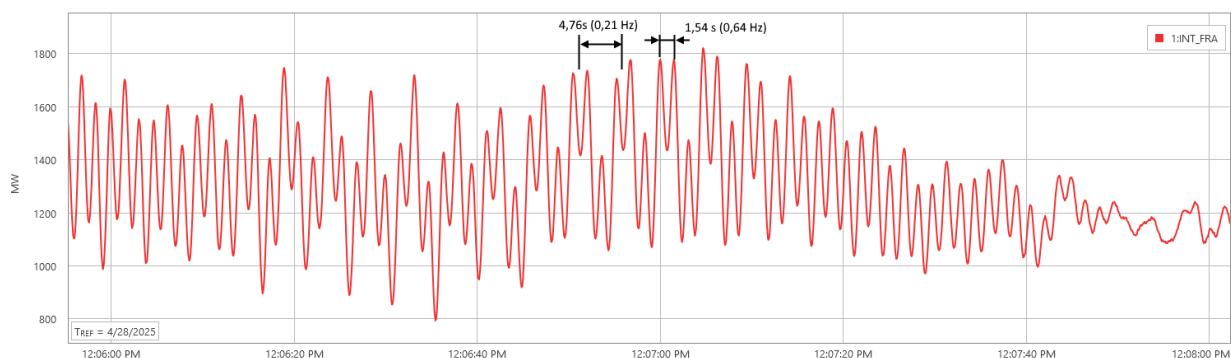
Almost at the end of this oscillation also the 0.2 Hz mode could be clearly seen coupled with the 0.6 Hz mode in the power exchange with France.

Figure 4. Exchange Spain-France between 12:06 to 12:08 (0.6 Hz oscillation)

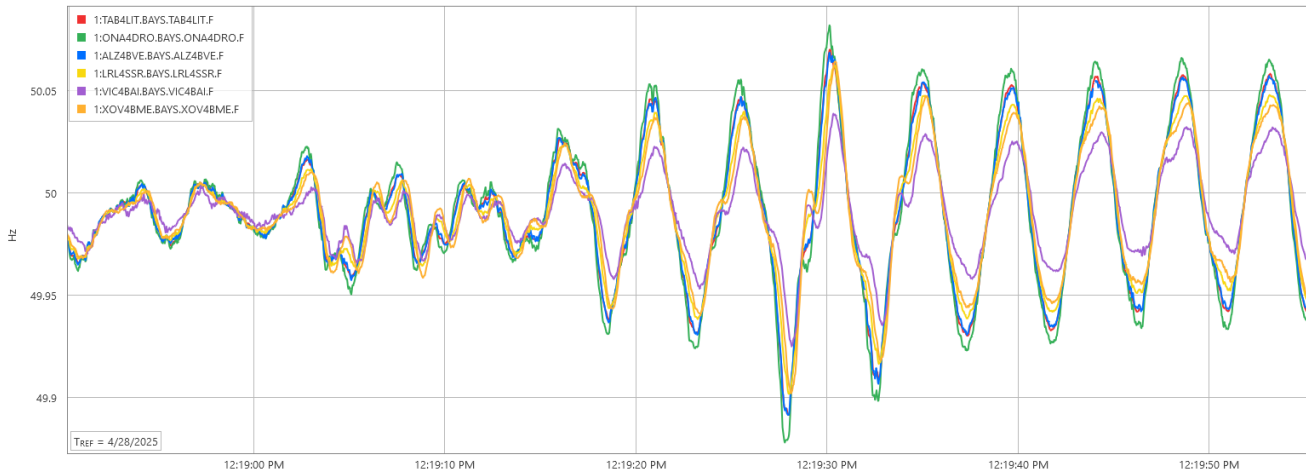
A detailed analysis revealed that the oscillation initially began at 0.6 Hz, and quickly afterwards the 0.2 Hz oscillation started. Although **PV Plant A** had increased its output from 250 MW to 350 MW at 12:15 h and no active power fluctuations were observed, variations in reactive power were indeed detected.

Figure 5. Initial moments of the 0.2 Hz oscillation where 0.6 Hz oscillation can also be observed

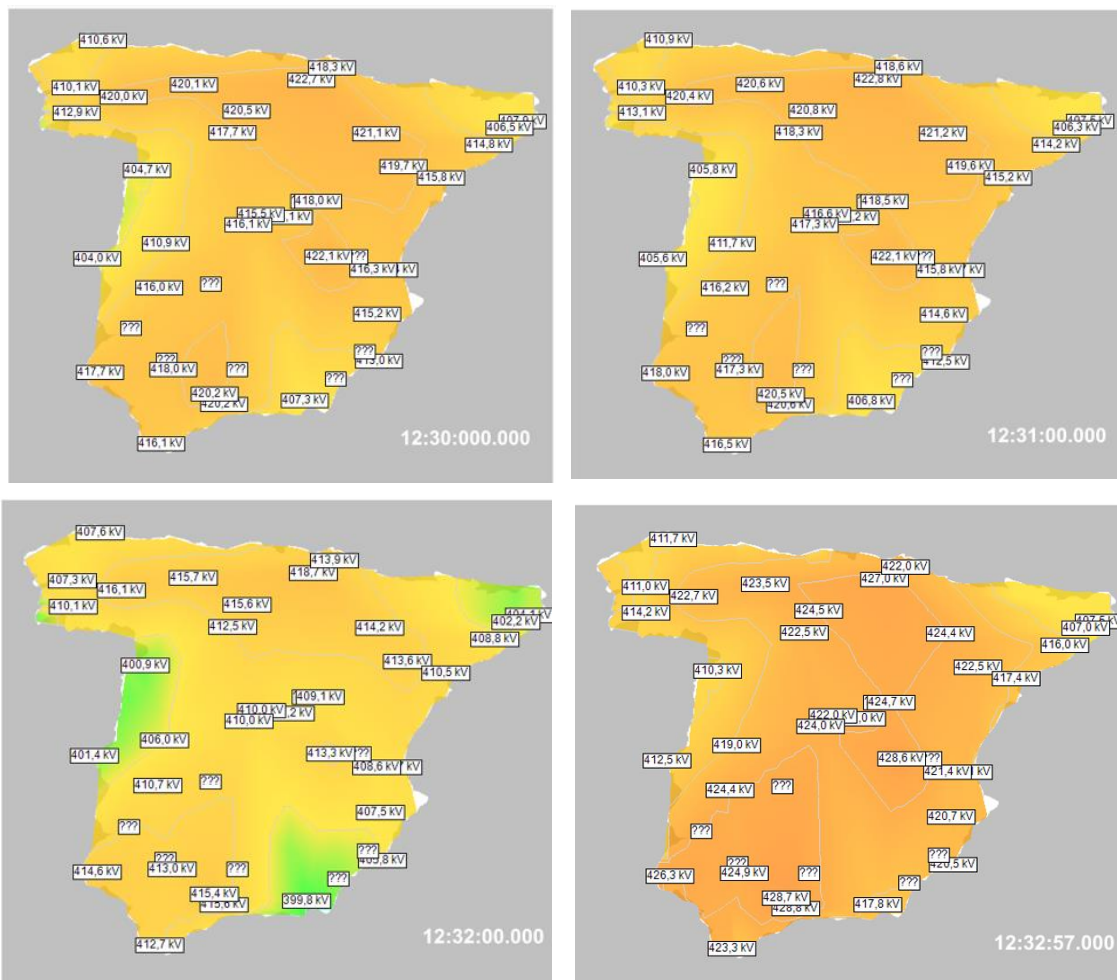
During the program adjustment window, which spans from -5 to +5 minutes, it is common for imbalances to occur between the activation of upward or downward regulation in each country. As a result, voltage fluctuations may arise. These variations must be managed primarily by generating units subject to Operating Procedure P.O. 7.4, which are required to provide dynamic voltage control. This is so because the available resources within the transmission network don't provide dynamic voltage control.

Figure 6. Phase-to-phase voltage in the Spanish 400 kV network

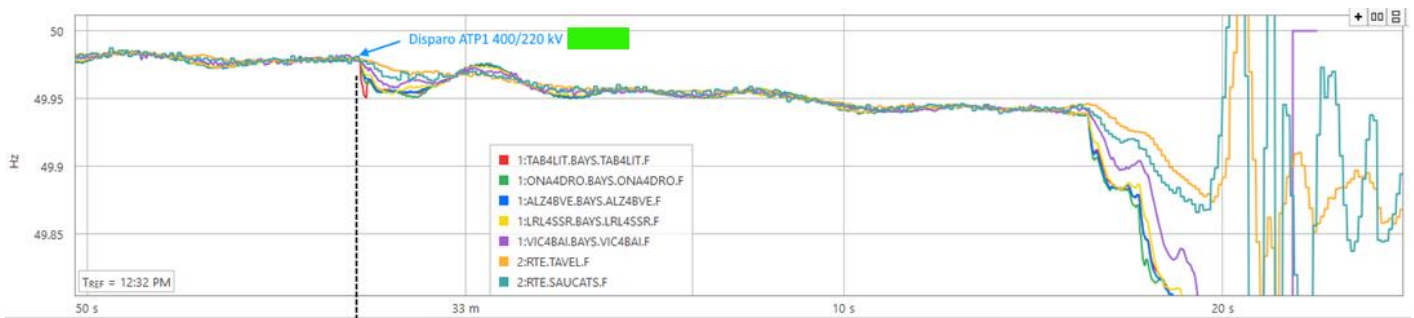
At 12:32:57 PM, a trip occurred at a **substation located in the province of Granada** involving the 220 kV side of 400/220 kV generation transformer, which at the time was supplying 355 MW to the transmission grid and absorbing 165 Mvar. The voltage at that transmission substation was below 418 kV, within the acceptable range. This is evidenced by the fact that, following the trip, voltages increased to 424 kV.

Figure 7. Evolution of the system before and after the trip in Granada

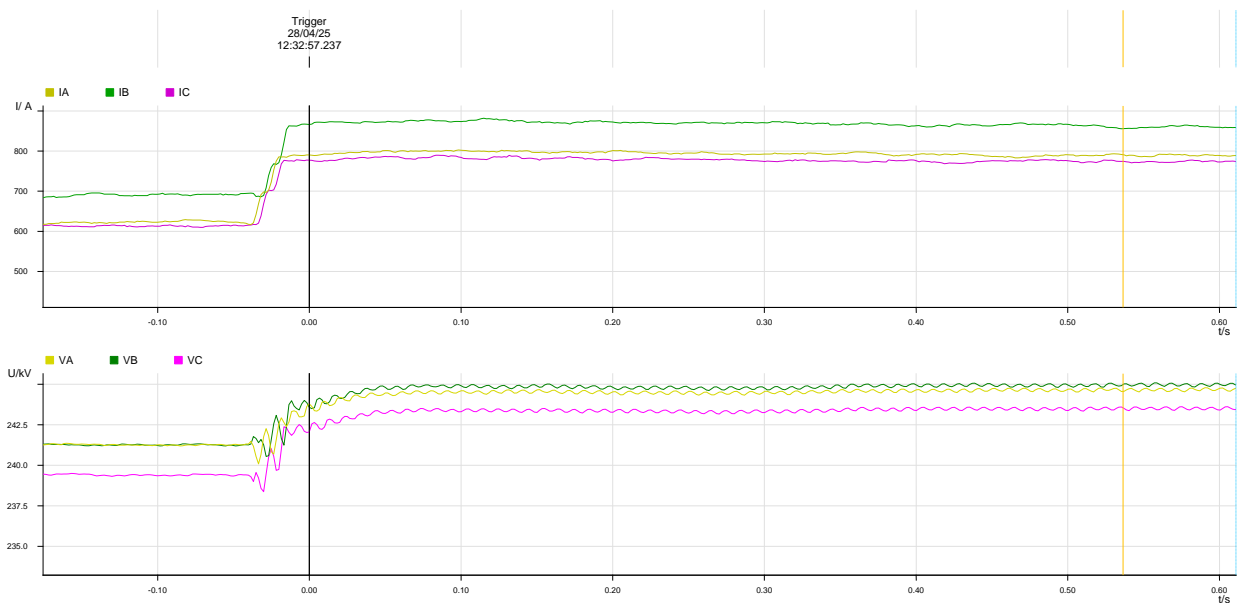
Figure 8. Line protection relay oscillography recorded simultaneously with the transformer trip⁵

Since there were no overvoltages on the transmission network 400 kV side —and the values were well below such thresholds—. It can, once again, be inferred that the cause lies in the generator transformer tap setting. As the system was recovering from previously low voltages, the transformer was likely operating with a tap position configured to maintain appropriate voltage levels at the 220 kV collector substation and the associated evacuation network. As voltages began to rise, the tap changers may not have responded quickly enough, potentially resulting in overvoltages on the secondary side without corresponding high voltages on the primary side of the transformer.

The disconnection of this installation is not correct, as the voltage in the point of connection with the transmission system remains within the limits established in grid codes.
